# **Contract No. DC/2022/02 Drainage Improvement Works at Yuen Long**

Pre-construction Survey and Translocation Report for Lin Fa Tei Section  
CH.A818.86 ~ CH.A500.00

**Wing Tat Civil Engineering Co. Limited**

**19-May-2025**

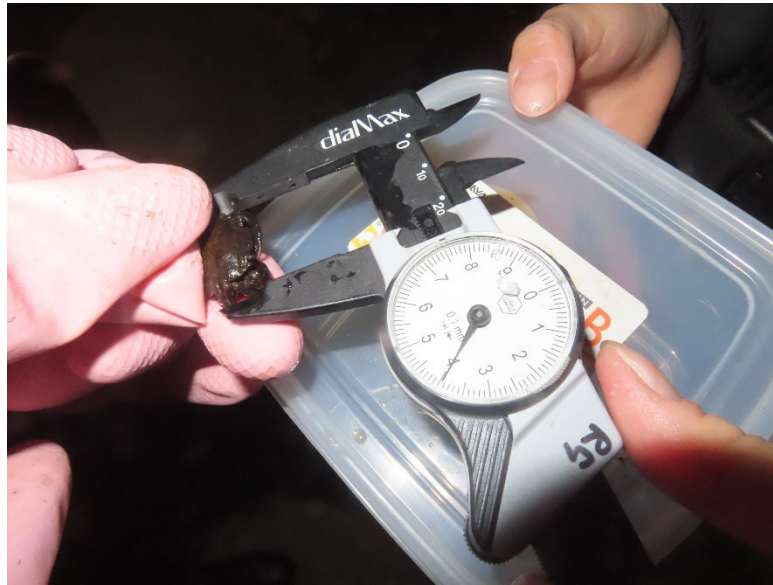
**Plate 1.** Size measurement of captured *C. anacoluthon* from previous pre-construction surveys.

- 2.4.5 Kick-netting was also conducted moving parallel from downstream to upstream, where hand net opening was positioned facing the water current at suitable locations. Using the toe or heel, the streambed substrate in front of the net was disturbed by kicking such that aquatic species dislodged by the disturbance were trapped in the net. All species with conservation importance captured were identified, measured, and photographed.

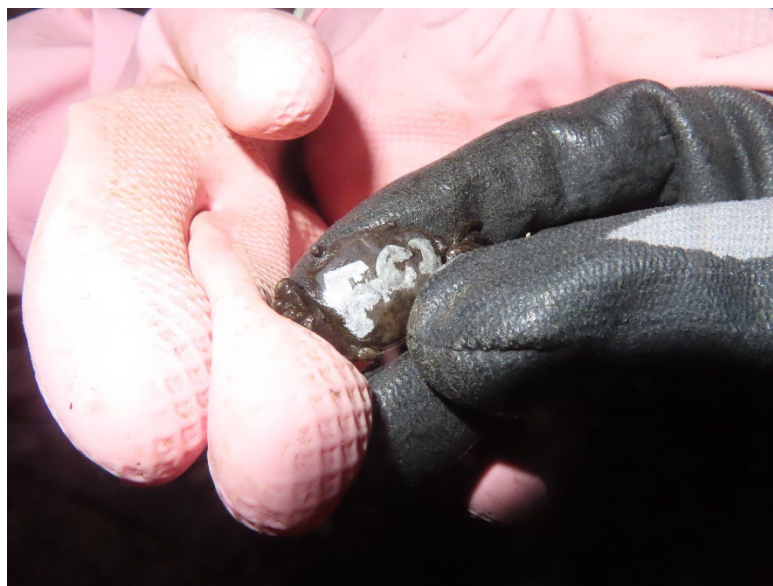
**Plate 2.** Marking the carapace of captured *C. anacoluthon* from previous pre-construction surveys.

- 2.4.6 Using an ink marker, dorsal side of the carapace of the captured individuals of *S. zanklon* and *C. anacoluthon* were marked with their assigned individual number/code. Earlier laboratory and field trials had established that crab survival and behaviour was unaffected by paint marking on the carapace (Bell *et. al.* 2003). However, no individuals of *S. zanklon* and *C. anacoluthon* were captured during this survey.

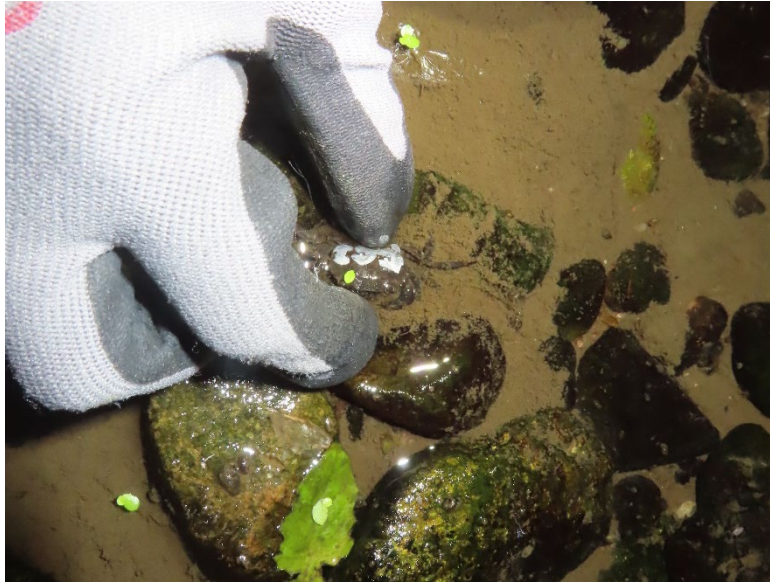
**Plate 3.** Releasing of *C. anacoluthon* to the receptor site from previous pre-construction surveys.

- 2.5.1 To avoid translocated individuals from re-entering the streams within the works area, suitable receptor sites outside and far from the affected sections were selected. However, no individuals of *S. zanklon* and *C. anacoluthon* were captured during this survey.

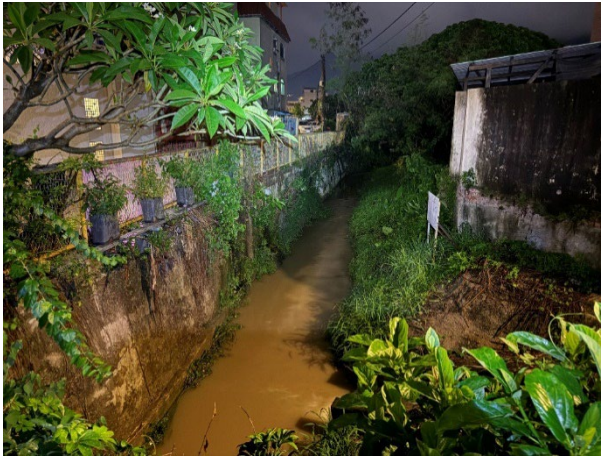
**Plate 4.** General site condition of CH.A818.86 ~ CH.A500.00.

- 3.1.1 The entire section of CH.A818.86 ~ CH.A500.00 is a channelised watercourse that flows between village houses. The flow speed of the section is moderate, and the substrate is dominated with silt. Pools of deeper water are found intermittently throughout the section. No natural banks occur on this section which is channelised along its length by vertical, concrete walls. The sides of the channel were moderately vegetated, with *Commelina diffusa*, *Pueraria montana* and *Neyraudia reynaudiana* being the dominant species.

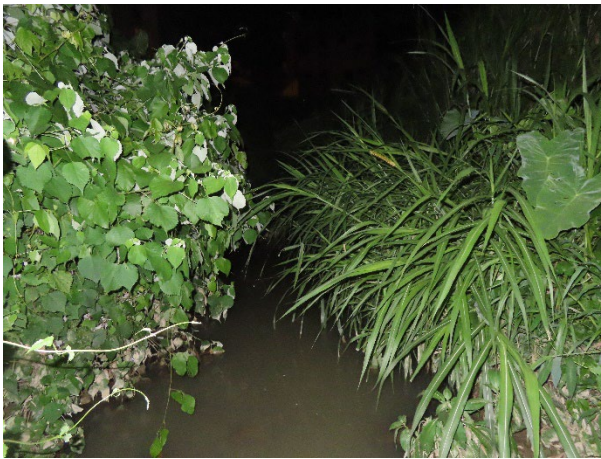
**Plate 5.** Site condition near CH.A818.86.

- 3.1.2 It was noted that the water depth of the section near CH.A818.86 is particularly deep, and could not be surveyed during all three days of the survey due to safety concerns. This section is also overgrown by vegetation, making it difficult to perform hand netting and kick-netting.

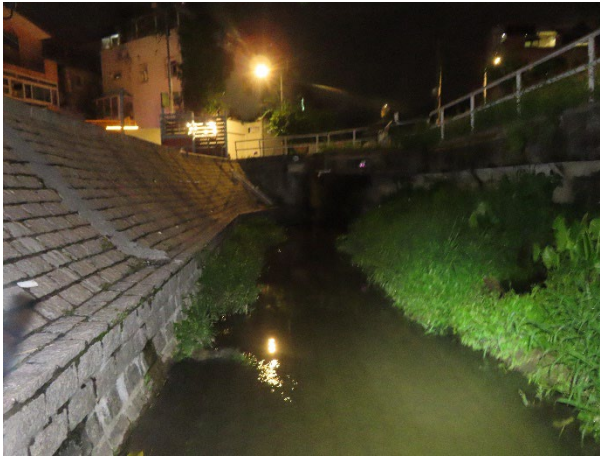
**Plate 6.** Site condition of the segment of watercourse near the bridge at Ngau Keng Tsuen.

- 3.1.3 The depth of water is noticeably lower around the bridge in Ngau Keng Tuen, and it could also be observed that the bottom of the segment is also constructed of concrete.

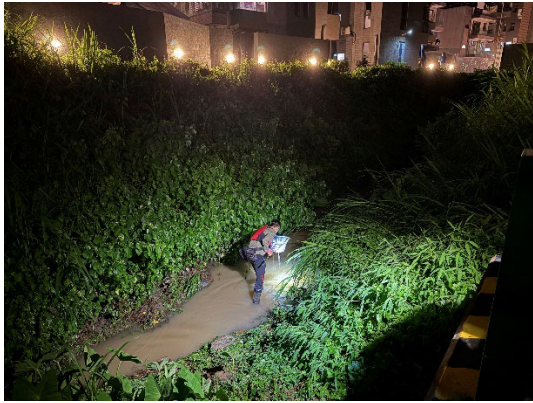
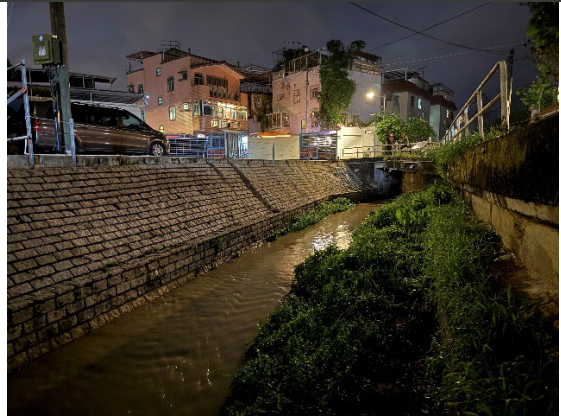
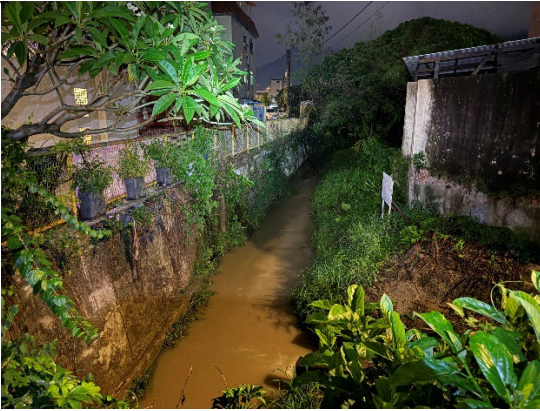
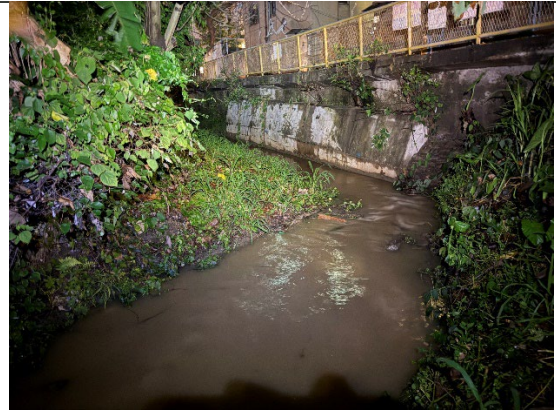
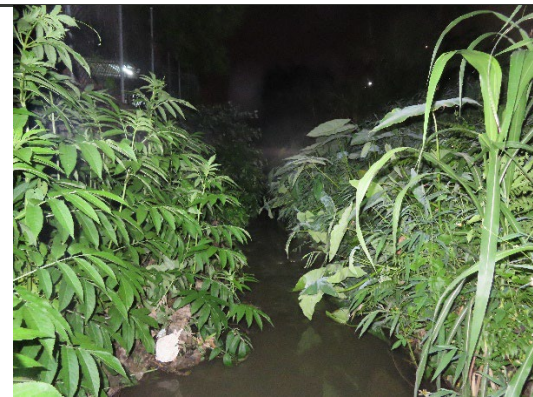
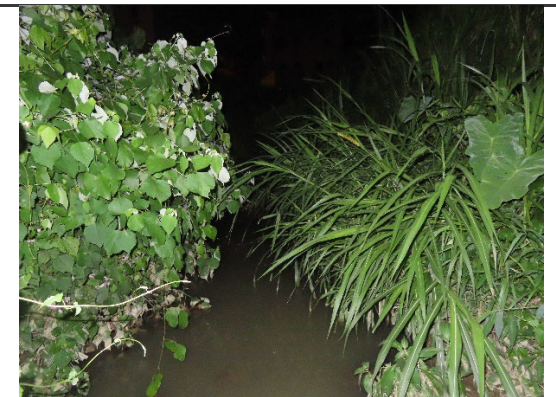
Collection Site CH.A818.86 ~ CH.A500.00

- 3.1.4 In general, the turbidity of the entire section is relatively high, and for most parts of the section the channel bottom is not visible. Invasive fishes occur in moderate abundance, while bloodworms were recorded in high abundance.
- 3.1.5 The water depth on 7 May 2025 was slightly higher than on 8 May and 9 May, a result of rain on that day. It was considered that that the rainfall did not cause a drastic change to the survey results given the low diversity of fauna within the watercourse.
- 3.1.6 More photos of the site conditions are provided in **Appendix C**.
